**Flood Control Project Maintenance
Levee Inspections**

Fall 2014 Levee Maintenance Deficiency Summary Report

Sacramento River Basin

**Flood Control Project Maintenance
Levee Inspections
Unit Cover Sheet
Fall 2014 Levee Inspection Results
Yolo County Service Area 6**

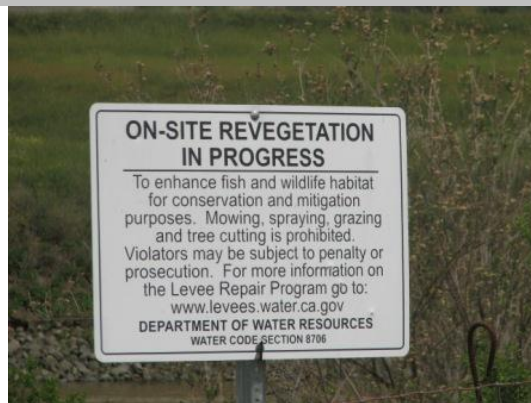
Photo 1 of 3 : FA_2014_NA0022_350_36_20141014_00041.jpg

LM Start	4.31	Rating **	A/W	Issue No.	36
LM End	4.57	Issue Type +	Ma	Location *	WS
Category	Earthen Levee			GPS Latitude/Longitude	
				Start	End
Item	Vegetation			38.767125 °	38.764582 °
				-121.693267 °	-121.690285 °
DWR ID	DWR_NA0022_01_s_2012_36				
Action/Comments					
Environmental Requirements.

USACE revegetation site photo spring 2012.

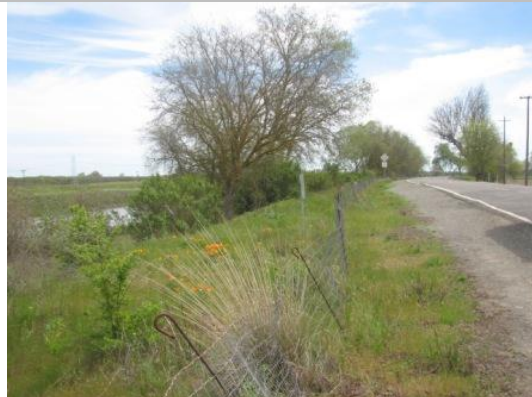
Photo 2 of 3 : FA_2014_NA0022_350_36_20141014_00042.jpg

LM Start	4.31	Rating **	A/W	Issue No.	36 (cont)
LM End	4.57	Issue Type +	Ma	Location *	WS
Category	Earthen Levee			GPS Latitude/Longitude	
				Start	End
Item	Vegetation			38.767125 °	38.764582 °
				-121.693267 °	-121.690285 °
DWR ID	DWR_NA0022_01_s_2012_36				
Action/Comments					
Environmental Requirements.

Another view of the site.

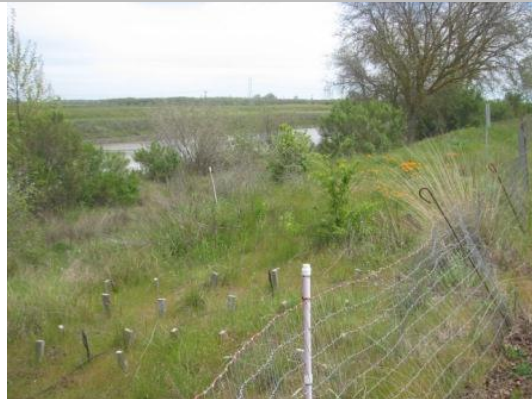
Photo 3 of 3 : FA_2014_NA0022_350_36_20141014_00043.jpg

LM Start	4.31	Rating **	A/W	Issue No.	36 (cont)
LM End	4.57	Issue Type +	Ma	Location *	WS

Fence, irrigation and stakes in the revegetation site.

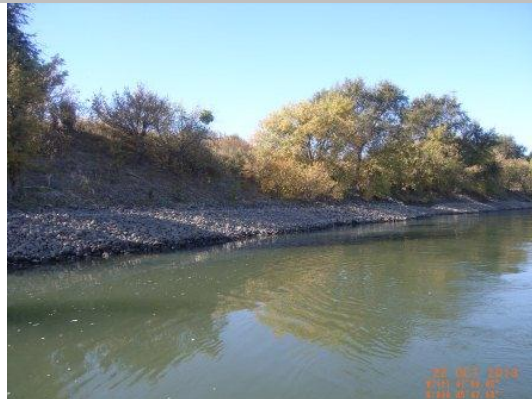
Photo 1 of 1 : FA_2014_NA0022_350_4_20141014_00006.jpg

LM Start	4.44	Rating **	M	Issue No.	4
LM End	5.04	Issue Type +	Ma	Location *	WS
Category	Supplemental			GPS Latitude/Longitude	
				Start	End
Item	USACE Erosion Survey			38.763486 °	38.763313 °
				-121.687567 °	-121.684038 °
DWR ID	DWR_NA0022_01_f_2014_4				
Action/Comments					
Inspector Comments: 2009 - Erosion into the levee toe. Some cobbles have been dumped into the erosion pockets. 2010 - Old cobble site starting to unravel. 2012 - Slope continues to steepen and new animal holes. 2013: Downstream cobble is unraveling. [2013 Site ID: SAC_85-4_R]

USACE 2013 Photo #1

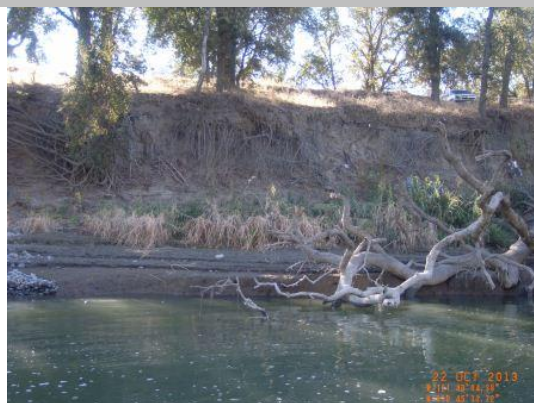
Photo 1 of 3 : FA_2014_NA0022_350_3_20141014_00003.jpg

LM Start	5.78	Rating **	M	Issue No.	3
LM End	5.86	Issue Type +	Ma	Location *	WS
Category	Supplemental			GPS Latitude/Longitude	
				Start	End
Item	USACE Erosion Survey			38.758877 °	38.759390 °
				-121.669365 °	-121.667500 °
DWR ID	DWR_NA0022_01_f_2014_3				
Action/Comments					
Inspector Comments: 2006 - Approximately 18 to 20 ft of bank near levee at the corner of the levee and the Freemont Weir. Vertical bank with undercutting/mass failure. 2007 - Staked at top of bank for monitoring. 2011 - Site has become significantly worse with more of the toe and lower bank eroded. Many trees have fallen since last year. 2012 - Site looks worse with more erosion around trees. 2013: Additional erosion into toe. [2013 Site ID: SAC_83-9_R]

USACE 2013 Photo #1

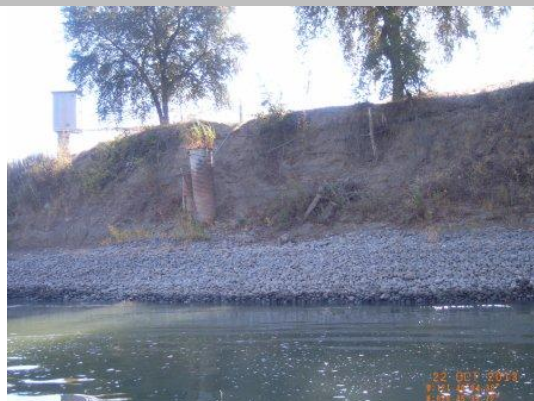
Photo 2 of 3 : FA_2014_NA0022_350_3_20141014_00004.jpg

LM Start	5.78	Rating **	M	Issue No.	3 (cont)
LM End	5.86	Issue Type +	Ma	Location *	WS

USACE 2013 Photo #2

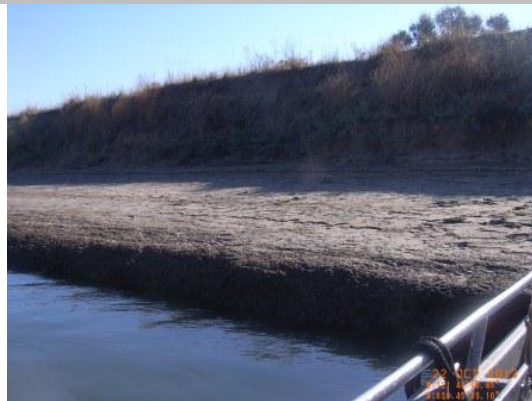
Photo 3 of 3 : FA_2014_NA0022_350_3_20141014_00005.jpg

LM Start	5.78	Rating **	M	Issue No.	3 (cont)	
LM End	5.86	Issue Type +	Ma	Location *	WS	
Category	Supplemental			GPS Latitude/Longitude		
				Start	End	
Item	USACE Erosion Survey			38.758877 °	38.759390 °	
				-121.669365 °	-121.667500 °	
DWR ID	DWR_NA0022_01_f_2014_3					
Action/Comments						
Inspector Comments: 2006 - Approximately 18 to 20 ft of bank near levee at the corner of the levee and the Freemont Weir. Vertical bank with undercutting/mass failure. 2007 - Staked at top of bank for monitoring. 2011 - Site has become significantly worse with more of the toe and lower bank eroded. Many trees have fallen since last year. 2012 - Site looks worse with more erosion around trees. 2013: Additional

USACE 2013 Photo #3
